**Flood Control Project Maintenance
Levee Inspections**

Maintenance Issue Types Only, Levee Inspection Report By Mile - Fall 2018

Reclamation District No. 0349 Sutter Island

Waterway	Bank	Unit Miles	Inspection Start/End	Inspector
Unit No. 01 Sacramento River	Right	1.59	11/08/2018 11/08/2018	David Julian

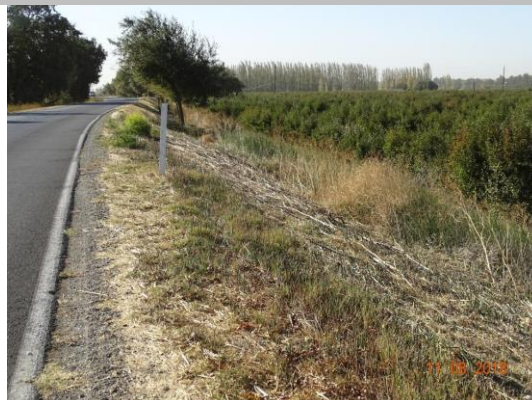
Photo 1 of 1 : FA_2018_RD0349_204_21_20181109_00029.jpg

LM Start	0.22	Rating **	M	Issue No.	21
LM End	0.26	Issue Type +	Ma	Location *	LS
Category	Earthen Levee			GPS Latitude/Longitude	
				Start	End
Item	Vegetation			38.324052°	38.323492°
				-121.577778°	-121.577952°
DWR ID	DWR_RD0349_01_f_2018_21				
Comment Code					
V1 : Control annual grass and weeds on the levee slopes and easements.					
Inspector Comment					
Remove vegetation all the way down to land side toe

Vegetation looking downstream on the land side slope (November 2018).

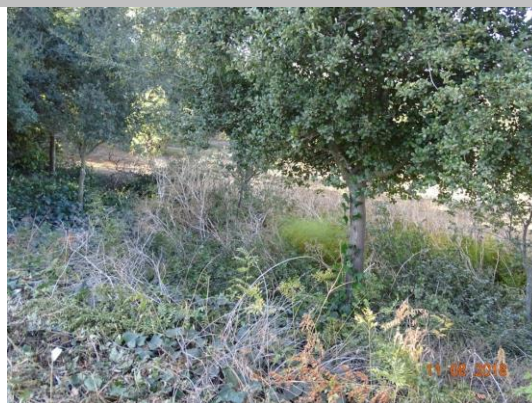
Photo 1 of 1 : FA_2018_RD0349_204_35_20181109_00030.jpg

LM Start	0.97	Rating **	U	Issue No.	35
LM End	0.97	Issue Type +	Ma	Location *	LS
Category	Earthen Levee			GPS Latitude/Longitude	
				Start	End
Item	Vegetation			38.313380 °	38.313380 °
				-121.578860 °	-121.578860 °
DWR ID	DWR_RD0349_01_f_2018_35				
Comment Code					
V2 : Remove the wild growth other than native grasses from the levee slopes.					
Inspector Comment					
Remove vegetation at land side toe

View of vegetation on the land side toe (November 2018).

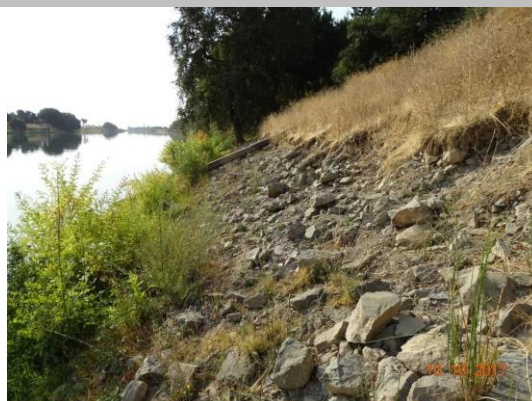
Photo 1 of 1 : FA_2018_RD0349_204_15_20180925_00003.jpg

Item	2017 Storm Damage		38.312911 °	38.312131 °								
			-121.578528 °	-121.578292 °								
DWR ID	DWR_RD0349_01_f_2017_15											
Comment Code												
Inspector Comment												
Levee Evaluation Comments Description: District Station 52+92 to 55+88, Sec. 06, T. 5 N. R. 4 E., M.D.M. Approximately 296 linear-feet of eroded area exists along the waterside levee slope of the Sacramento River (Unit 1). Erosion commences at approximately 3/4 of the way down the slope from the crown and extends into the rip rap. Some rip rap has been pulled off in this section. Site ID No: 318 Site Designation: LMA-145 Repair Type: Erosion Rating: Area of Concern Field Date: 7/28/2017 Notes: slope too steep, vegetation too thick for clear inspection, no direct visual of damage

Waterside erosion at LM 1.02.

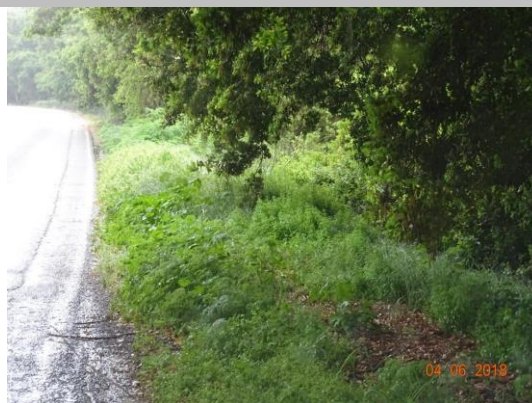
Photo 1 of 1 : FA_2018_RD0349_204_29_20180925_00007.jpg

LM Start	1.20	Rating **	U	Issue No.	29
LM End	1.21	Issue Type +	Ma	Location *	LS
Category	Earthen Levee			GPS Latitude/Longitude	
				Start	End
Item	Vegetation			38.310110 °	38.309955 °
				-121.577608 °	-121.577495 °
DWR ID	DWR_RD0349_01_f_2017_29				
Comment Code					
V2 : Remove the wild growth other than native grasses from the levee slopes.					
Inspector Comment

Manage landside vegetation to allow inspection and access.

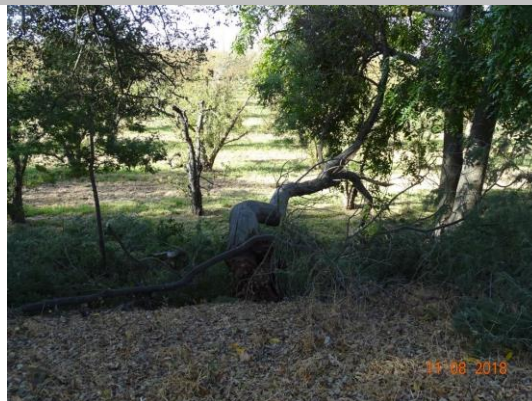
Photo 1 of 1 : FA_2018_RD0349_204_36_20181109_00031.jpg

LM Start	1.40	Rating **	M	Issue No.	36
LM End	1.40	Issue Type +	Ma	Location *	LS
Category	Earthen Levee			GPS Latitude/Longitude	
				Start	End
Item	Encroachments			38.307553 °	38.307553 °
				-121.575848 °	-121.575848 °
DWR ID	DWR_RD0349_01_f_2018_36				
Comment Code					
TR : Tree or limb					
Inspector Comment

View of fallen tree limb on the land side toe (November 2018).

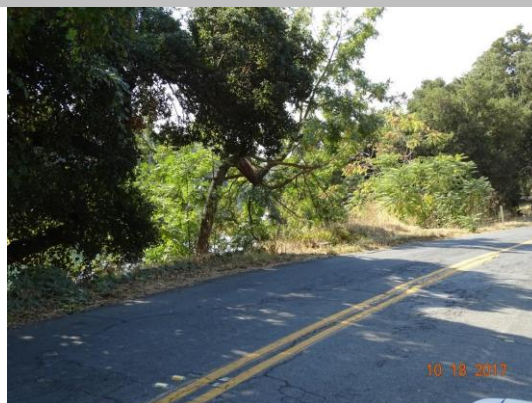
Photo 1 of 1 : FA_2018_RD0349_205_44_20180925_00029.jpg

LM Start	0.04	Rating **	M	Issue No.	44
LM End	0.08	Issue Type +	Ma	Location *	WS
Category	Earthen Levee			GPS Latitude/Longitude	
				Start	End
Item	Vegetation			38.304877 °	38.304719 °
				-121.575384 °	-121.576083 °
DWR ID	DWR_RD0349_02_f_2017_44				
Comment Code					
V2 : Remove the wild growth other than native grasses from the levee slopes.					
Inspector Comment					
Waterside vegetation should be removed or thinned to 20 feet from crown to allow inspection and access.

Waterside vegetation should be removed or thinned to 20 feet from crown to allow inspection and access.

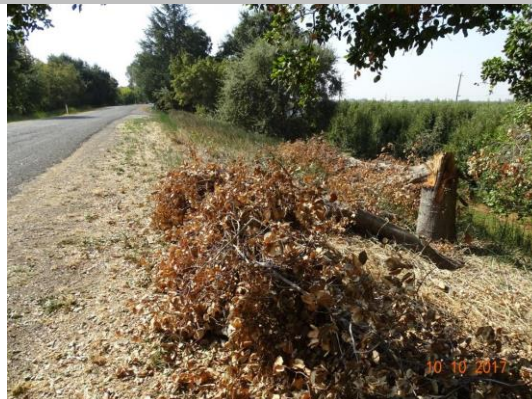
Photo 1 of 1 : FA_2018_RD0349_205_7_20180925_00006.jpg

Fallen tree on landside slope.

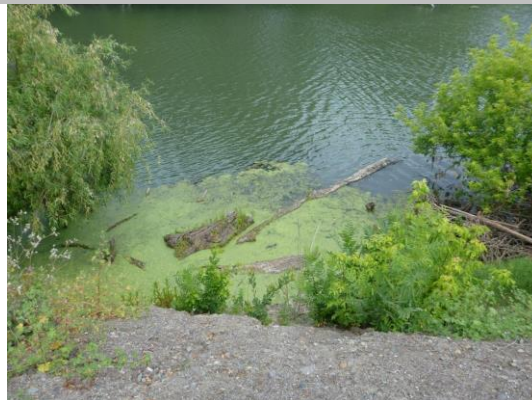
Photo 3 of 3 : FA_2018_RD0349_205_40_20180925_00020.jpg

LM Start	1.33	Rating **	M	Issue No.	40 (cont)	
LM End	1.49	Issue Type +	Ma	Location *		
Category	Supplemental			GPS Latitude/Longitude		
				Start		End
Item	2017 Storm Damage			38.288727 °		38.286475 °
				-121.583823 °		-121.585026 °
DWR ID	DWR_RD0349_02_f_2017_40					
Comment Code						
Inspector Comment						
Levee Evaluation Comments						
Description:						
Site ID No:66						
Site Designation:DWR_RD0349_02_s_2012_28						
Repair Type: Erosion						
Rating:Area of Concern						
Field Date:6/7/2017						
Notes: dense vegetation and large trees hindered visibility; slope riprap appeared failing in some parts

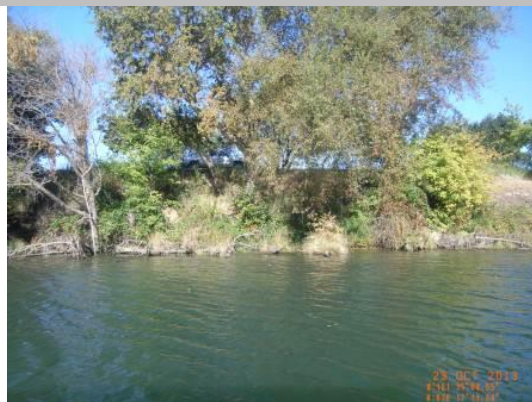
Photo 1 of 1 : FA_2018_RD0349_205_27_20181114_00105.jpg

LM Start	1.33	Rating **	A/W	Issue No.	27
LM End	1.49	Issue Type +	Ma	Location *	WS
Category	Supplemental			GPS Latitude/Longitude	
				Start	End
Item	2017 USACE Erosion Survey, DRAFT			38.288727 °	38.286475 °
				-121.583823 °	-121.585026 °
DWR ID	DWR_RD0349_02_f_2018_27

Comment Code					
Inspector Comment					
2017 Site ID: STM 24.7 R					
Status: Critical					
2017 Field Notes: No observed change.					
Site History: 1997 - Erosion of very sandy levee behind large stand of riparian vegetation on top right bank. Dry ravel of sand. 1999 - Quarry waste rock was dumped down the levee slope; poor repair job; still eroding in places. Eroding at midslope off fabric. 2005 - Length revised, only the middle 150 - 200 ft are eroding. 2006 - Some rock/small material dumped down the bank but it is slowly unraveling. Upstream end is unraveling faster. Steep slope with poor gradation so fines are washing out. 2010 - Lots of overhanging trees and erosion pockets. 2011 - This site is upgraded to CRITICAL. Near vertical bank at the downstream end. New erosion at various locations throughout the site.

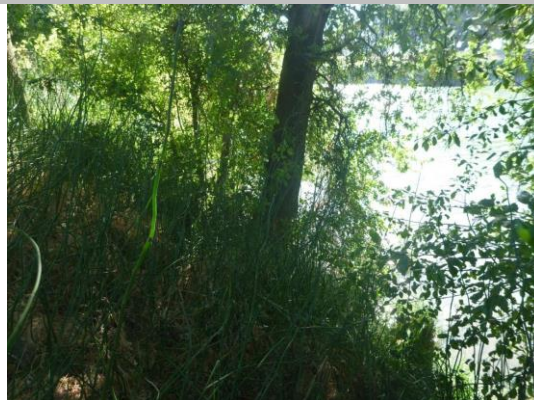
Photo 3 of 3 : FA_2018_RD0349_205_34_20180925_00012.jpg

Item	2017 Storm Damage		38.286886 °	38.286861 °								
			-121.584589 °	-121.584622 °								
DWR ID	DWR_RD0349_02_f_2017_34											
Comment Code												
Inspector Comment												
<p>Levee Evaluation Comments</p> <p>Description: District Station 77+56 to 77+68, Sec. 18, T. 5 N. R. 4 E., M.D.M. Approximately 12 linear feet of erosion/sloughing exists along the water side slope of Steamboat Slough (Unit 2). The erosion area commences approximately halfway down the slope from the levee crown and extends to the waterside toe around existing trees. No rip rap is visible in this area.</p> <p>Site ID No: 322</p> <p>Site Designation: LMA-149</p> <p>Repair Type: Erosion</p> <p>Rating: Area of Concern</p> <p>Field Date: 7/28/2017</p> <p>Notes: no berm</p>

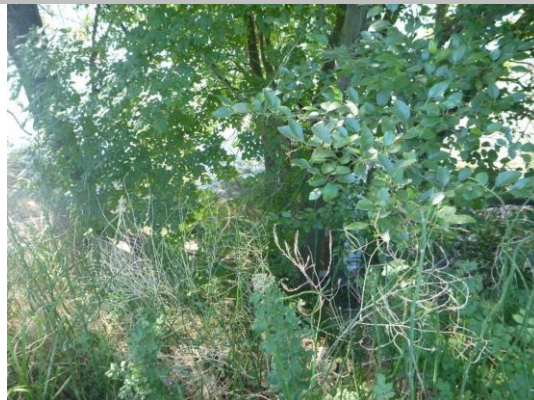
Photo 1 of 2 : FA_2018_RD0349_205_37_20180925_00015.jpg

Item	2017 Storm Damage		38.286708 °	38.286569 °								
			-121.584839 °	-121.585042 °								
DWR ID	DWR_RD0349_02_f_2017_37											
Comment Code												
Inspector Comment												
<p>Levee Evaluation Comments</p> <p>Description: District Station 78+51 to 79+28, Sec. 18, T. 5 N. R. 4 E., M.D.M. Approximately 77 linear feet of erosion and scour exist along the water side slope of Steamboat Slough (Unit 2). The erosion area commences approximately halfway down the slope from the levee crown and extends to the waterside toe around existing trees. No rip rap is visible in this area.</p> <p>Site ID No: 323</p> <p>Site Designation: LMA-150</p> <p>Repair Type: Erosion</p> <p>Rating: Area of Concern</p> <p>Field Date: 7/28/2017</p> <p>Notes: no berm</p>

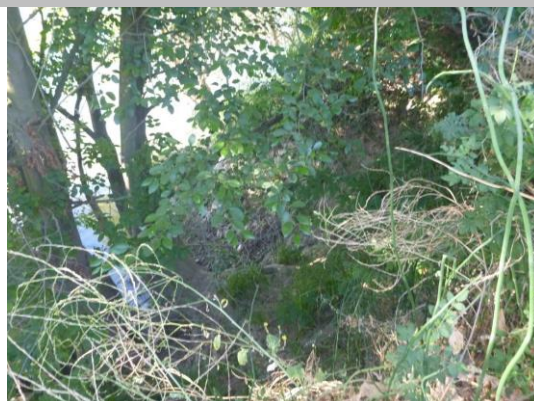
Photo 2 of 2 : FA_2018_RD0349_205_37_20180925_00016.jpg

LM Start	1.48	Rating **	A/W	Issue No.	37 (cont)
LM End	1.49	Issue Type +	Ma	Location *	
Category	Supplemental			GPS Latitude/Longitude	
				Start	End
Item	2017 Storm Damage			38.286708 °	38.286569 °
				-121.584839 °	-121.585042 °
DWR ID	DWR_RD0349_02_f_2017_37				
Comment Code					
Inspector Comment					
<p>Levee Evaluation Comments</p> <p>Description: District Station 78+51 to 79+28, Sec. 18, T. 5 N. R. 4 E., M.D.M. Approximately 77 linear feet of erosion and scour exist along the water side slope of Steamboat Slough (Unit 2). The erosion area commences approximately halfway down the slope from the levee crown and extends to the waterside toe around existing trees. No rip rap is visible in this area.</p> <p>Site ID No: 323</p> <p>Site Designation: LMA-150</p> <p>Repair Type: Erosion</p> <p>Rating: Area of Concern</p> <p>Field Date: 7/28/2017</p> <p>Notes: no berm</p>

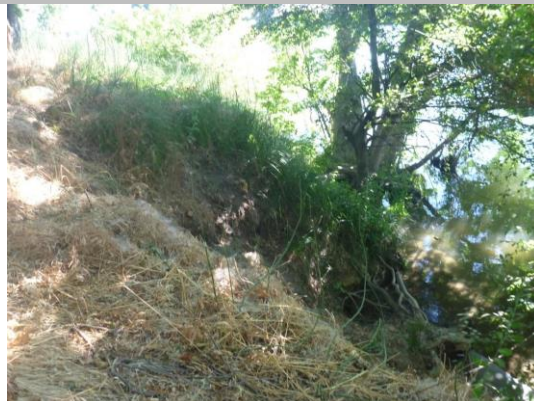
LM Start	2.11	Rating **	A/W	Issue No.	41
LM End	2.13	Issue Type +	Ma	Location *	
Category	Supplemental			GPS Latitude/Longitude	
				Start	End
Item	2017 Storm Damage			38.279039 °	38.278806 °
				-121.589664 °	-121.589783 °
DWR ID	DWR_RD0349_02_f_2017_41				
Comment Code					
Inspector Comment					
Levee Evaluation Comments					
Description:District Station 112+11 to 113+04, Sec. 13, T. 5 N. R. 3 E., M.D.M. Approximately 93 linear feet of erosion exists along the water side slope of Steamboat Slough (Unit 2). The erosion area commences approximately 3/4 of the way down the slope from the levee crown and extends to the waterside toe around existing trees. No rip rap is visible in this area.					
Site ID No:324					
Site Designation:LMA-151					
Repair Type: Erosion					
Rating:Serious					
Field Date:7/28/2017					
Notes: no berm

LM Start	2.11	Rating **	A/W	Issue No.	41 (cont)
LM End	2.13	Issue Type +	Ma	Location *	
Category	Supplemental			GPS Latitude/Longitude	
				Start	End
Item	2017 Storm Damage			38.279039 °	38.278806 °
				-121.589664 °	-121.589783 °
DWR ID	DWR_RD0349_02_f_2017_41				
Comment Code					
Inspector Comment					
Levee Evaluation Comments					
Description:District Station 112+11 to 113+04, Sec. 13, T. 5 N. R. 3 E., M.D.M. Approximately 93 linear feet of erosion exists along the water side slope of Steamboat Slough (Unit 2). The erosion area commences approximately 3/4 of the way down the slope from the levee crown and extends to the waterside toe around existing trees. No rip rap is visible in this area.					
Site ID No:324					
Site Designation:LMA-151					
Repair Type: Erosion					
Rating:Serious					
Field Date:7/28/2017					
Notes: no berm

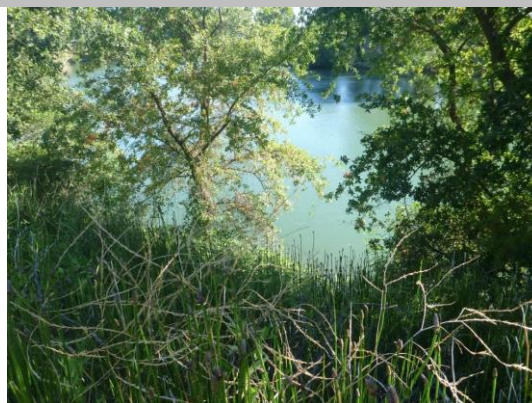
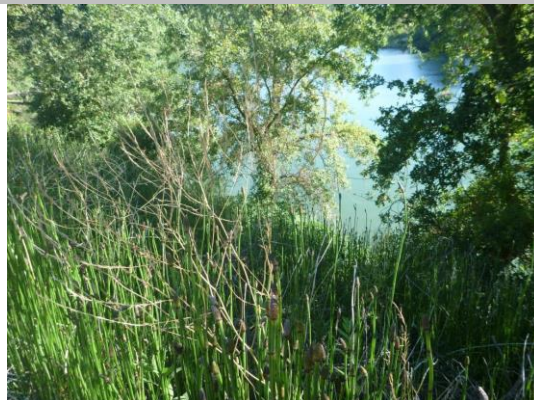
LM Start	2.43	Rating **	A/W	Issue No.	42
LM End	2.44	Issue Type +	Ma	Location *	
Category	Supplemental			GPS Latitude/Longitude	
				Start	End
Item	2017 Storm Damage			38.275131 °	38.275036 °
				-121.590594 °	-121.590461 °
DWR ID	DWR_RD0349_02_f_2017_42				
Comment Code					
Inspector Comment					
Levee Evaluation Comments					
Description:District Station 128+76 to 129+27, Sec. 13, T. 5 N. R. 3 E., M.D.M. Approximately 51 linear feet of erosion exists along the water side slope of Steamboat Slough (Unit 2). The erosion area commences approximately 3/4 of the way down the slope from the levee crown and extends to the waterside toe around existing trees. No rip rap is visible in this area.					
Site ID No:325					
Site Designation:LMA-152					
Repair Type: Erosion					
Rating:Area of Concern					
Field Date:7/28/2017					
Notes: acess very difficult, steep slope, dense brush

Comment Code					
Inspector Comment					
Levee Evaluation Comments					
Description:District Station 128+76 to 129+27, Sec. 13, T. 5 N. R. 3 E., M.D.M. Approximately 51 linear feet of erosion exists along the water side slope of Steamboat Slough (Unit 2). The erosion area commences approximately 3/4 of the way down the slope from the levee crown and extends to the waterside toe around existing trees. No rip rap is visible in this area.					
Site ID No:325					
Site Designation:LMA-152					
Repair Type: Erosion					
Rating:Area of Concern					
Field Date:7/28/2017					
Notes: access very difficult, steep slope, dense brush

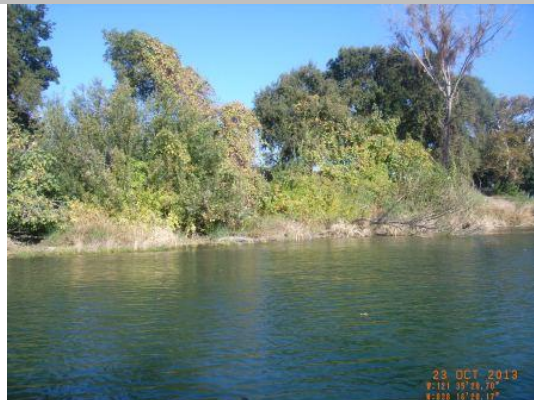
LM Start	2.56	Rating **	A/W	Issue No.	24
LM End	2.69	Issue Type +	Ma	Location *	WS
Category	Supplemental			GPS Latitude/Longitude	
				Start	End
Item	2017 USACE Erosion Survey, DRAFT			38.273854 °	38.271998 °
				-121.588745 °	-121.589424 °
DWR ID	DWR_RD0349_02_f_2018_24				
Comment Code					
Inspector Comment					
2017 Site ID: STM 23.6 R					
Status: Eroding					
2017 Field Notes: Previously observed quarry stone at the downstream end is now gone. Significant erosion at upstream end. Fresh sedimentation on the downstream end.					
Site History: 2011 - Toe scour at the tidal zone. 2015 - New tree pop-out and minor new erosion. 2016 - New erosion at upstream end.

LM Start	2.56	Rating **	A/W	Issue No.	24 (cont)
LM End	2.69	Issue Type +	Ma	Location *	WS
Category	Supplemental			GPS Latitude/Longitude	
				Start	End
Item	2017 USACE Erosion Survey, DRAFT			38.273854 °	38.271998 °
				-121.588745 °	-121.589424 °
DWR ID	DWR_RD0349_02_f_2018_24				
Comment Code					
Inspector Comment					
2017 Site ID: STM 23.6 R					
Status: Eroding					
2017 Field Notes: Previously observed quarry stone at the downstream end is now gone. Significant erosion at upstream end. Fresh sedimentation on the downstream end.					
Site History: 2011 - Toe scour at the tidal zone. 2015 - New tree pop-out and minor new erosion. 2016 - New erosion at upstream end.

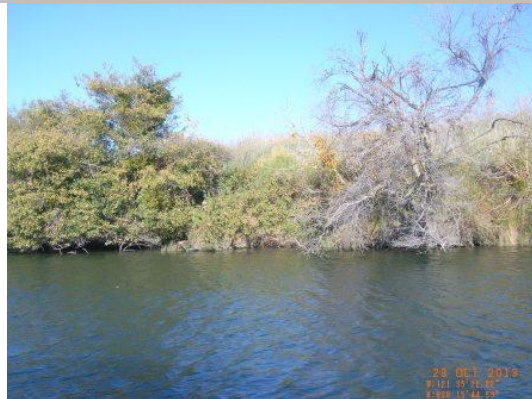
Photo 1 of 1 : FA_2018_RD0349_205_23_20181114_00007.jpg

LM Start	3.38	Rating **	M	Issue No.	23
LM End	3.49	Issue Type +	Ma	Location *	WS
Category	Supplemental			GPS Latitude/Longitude	
				Start	End
Item	2017 USACE Erosion Survey, DRAFT			38.262510 °	38.262533 °
				-121.589481 °	-121.591690 °
DWR ID	DWR_RD0349_02_f_2018_23				
Comment Code					
Inspector Comment					
2017 Site ID: STM 22.8 R					
Status: Eroding					
2017 Field Notes: No observed change.					
Site History: 2010 - Slumping sections on the lower bank, appears to be scouring around the trees. 2011 - Soil beach at toe.

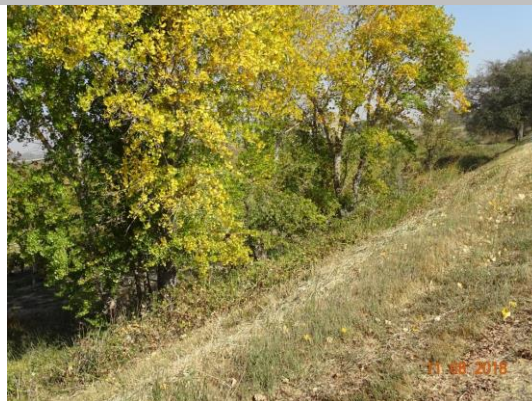
Photo 1 of 1 : FA_2018_RD0349_205_31_20181109_00100.jpg

View looking downstream of vegetation part way down the land side slope (November 2018).

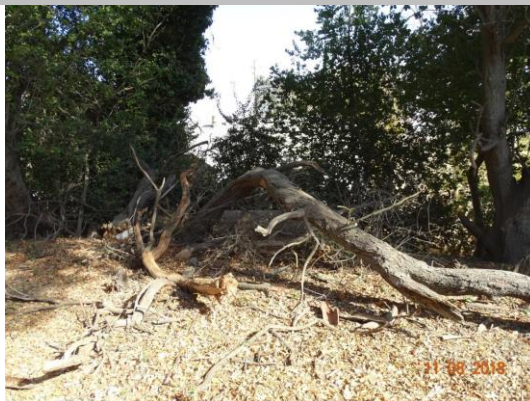
Photo 1 of 1 : FA_2018_RD0349_206_67_20181109_00095.jpg

View of down tree on the land side shoulder (November 2018).

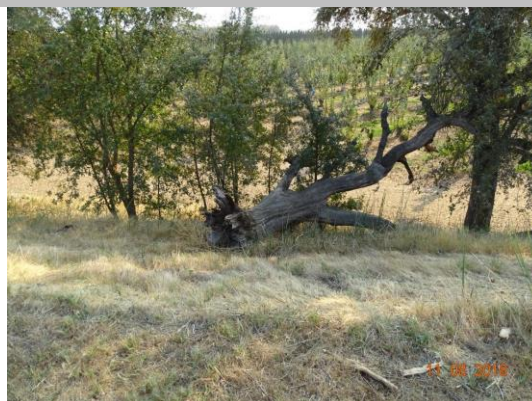
Photo 1 of 1 : FA_2018_RD0349_206_102_20181109_00088.jpg

View of tree on the land side slope (November 2018).
